# MICROSTRUCTURE AND FRACTOGRAPHIC ANALYSIS OF DAMAGE REASONS OF COGWHEEL

The article provides an analysis of the damaged cogwheel, which was used as the drive wheel (pinion) in the steering gear box of the construction machine. The degradation of the cogwheel arose during the warranty period, after seven months of using of the construction machine. The experimental analysis revealed that the cause of the degradation of the cogwheel was due to high mechanical stress in the operating conditions of construction machine.

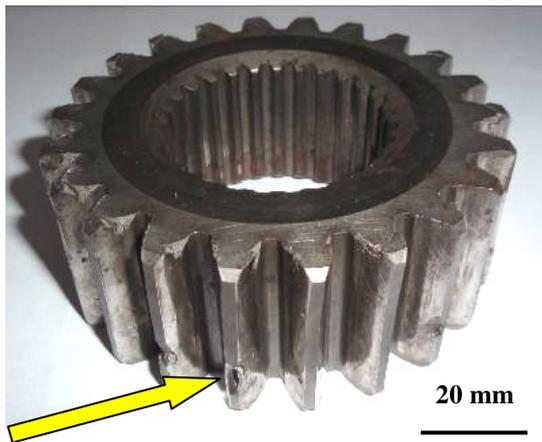
The summary view of the analyzed damaged cogwheel is shown in Fig. 1. Several failures were macroscopically observed on the cogwheel, for example: cracks, broken and turgidity gear, plastic deformation of cogwheel's material and the local separation of the material. More detailed view of the damaged cogwheel is shown in Figs. 2 to 5.

Fig. 1. View on the damaged cogwheel

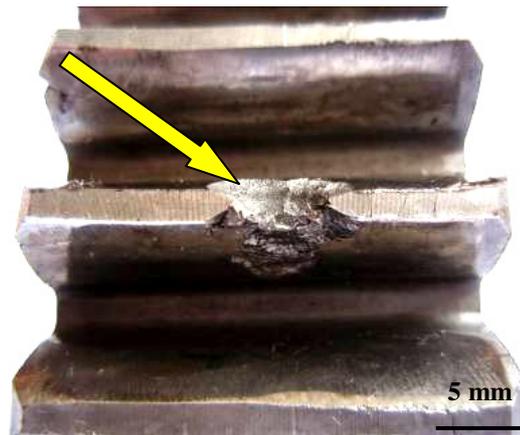
Fig. 2. Detail of the broken part of the tooth of cogwheel

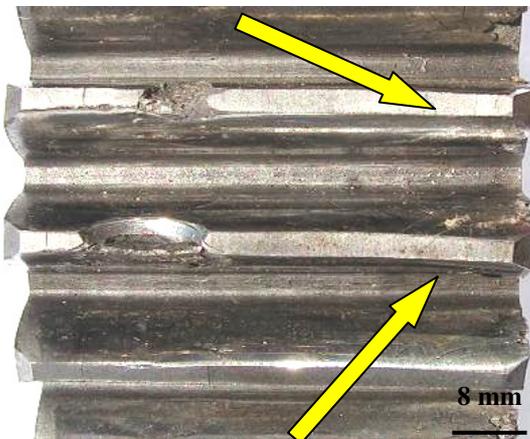
Fig. 3. View of deformed gear

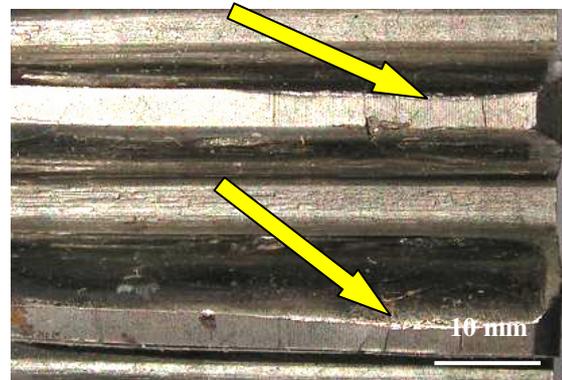
Fig. 4. Changes in geometry, significant wear of cogwheel's teeth

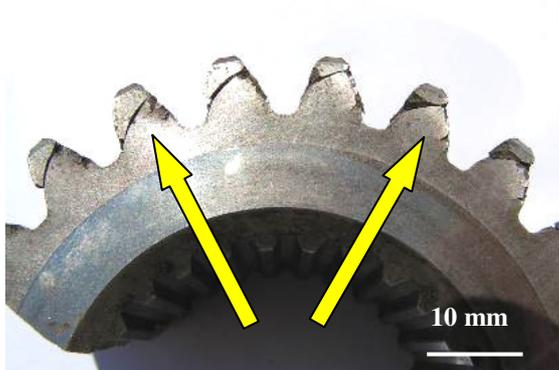
Fig. 5. View of the cracked tooth of the cogwheel

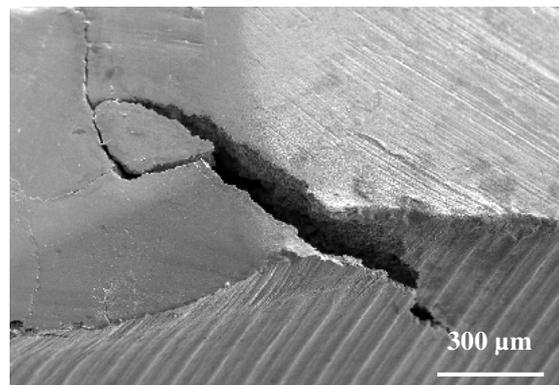
The surface of cogwheel's tooth is documented in Fig. 6. In this figure we can observe plastic deformation, cracks and bruising

Fig. 6. Plastic deformation, cracks, bruising of cogwheel's tooth, SEM

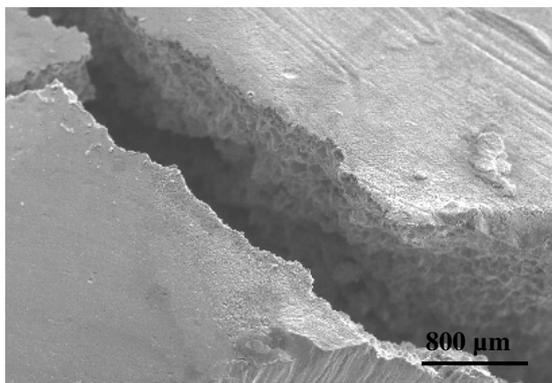
of the functional area of the tooth. More detailed view of the significant crack, which is spreading to the functional area of the tooth, is shown in Fig. 7. In the upper part of Fig. 8 can be seen the net of the cracks spreading in to the cross-section of material and separation of material from the

Fig. 7. The detail view of the crack, SEM

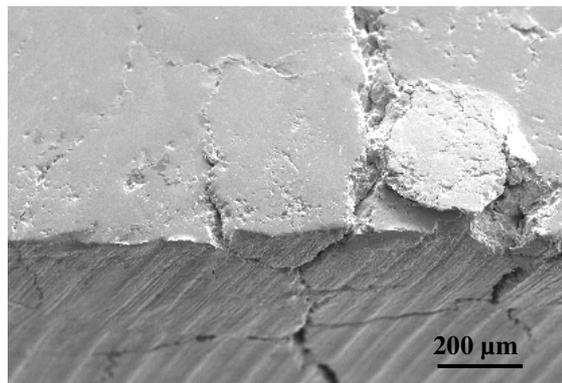
Fig. 8. The net of the cracks, SEM

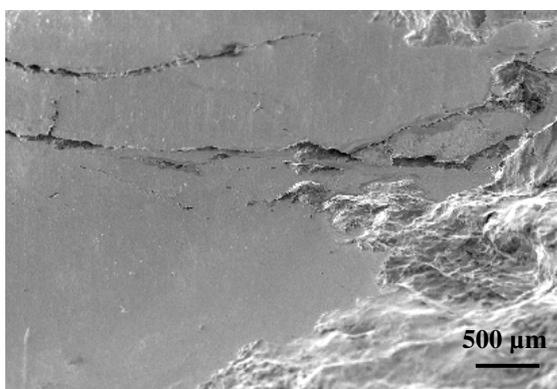
functional areas of the cogwheel's tooth. The net of cracks was also observed in the side face of the cogwheel. Similarly, elsewhere in the functional areas of the cogwheel's tooth further observe the cracks and the separation of the material (Fig. 9).

Fig. 9. The cracks and separation of material from the cogwheels, SEM

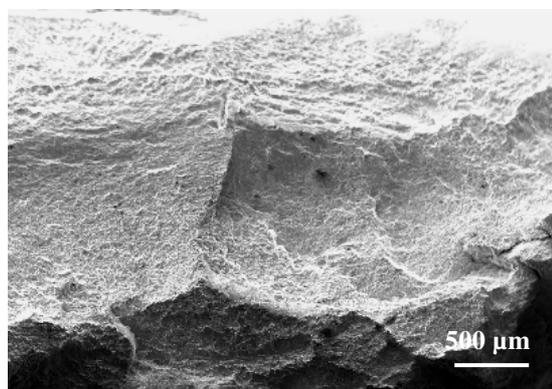
Fig. 10. The functional surface of cogwheel, fracture surface SEM

Fig. 10 documents the fracture surface of the functional areas of the tooth in place of a separate material of cogwheel. In Fig. 11 is observed a dominant ratio of intercrystalline failure of material [7, 8]. The sample was cut from the damaged cogwheel upright to the tooth by cutting disc with cooling water. The sample was molded using press into the compound Phenocure by conventional metallographic

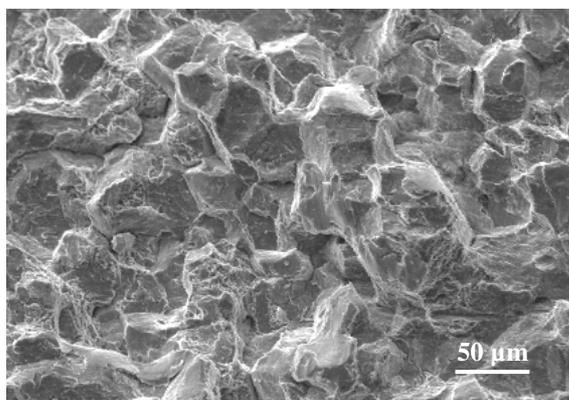
Fig. 11. The predominant ratio of the intercrystalline failure, SEM

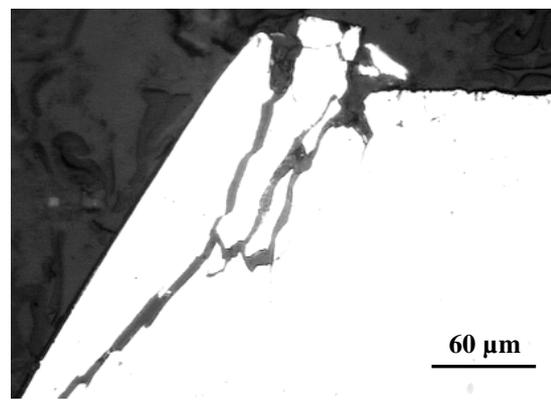
Fig. 12. The deformed cogwheels tooth, cracks, polished condition

procedures. The cracked and deformed tooth of cogwheel is shown in Fig. 12 and 13. The large cracks spread in the cross-section of the cogwheel's tooth. The condition of sample after etching 3 % Nital is documented in Fig. 14 and 15. The spread of cracks at grain boundaries is observed in the microstructure of cross-section of the tooth. The microstructure of surface diffusional layer of cogwheel's teeth corresponds

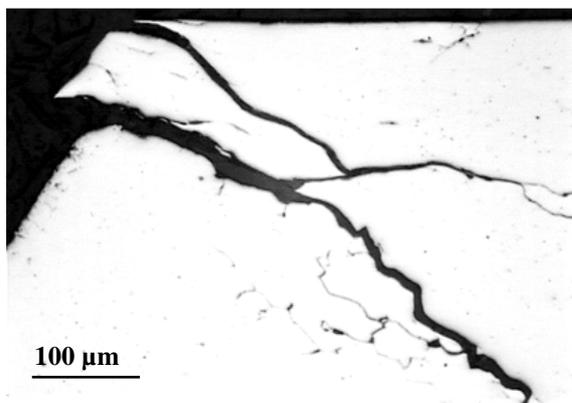
Fig. 13. The deformed cogwheel's tooth, cracks, another place, polished condition

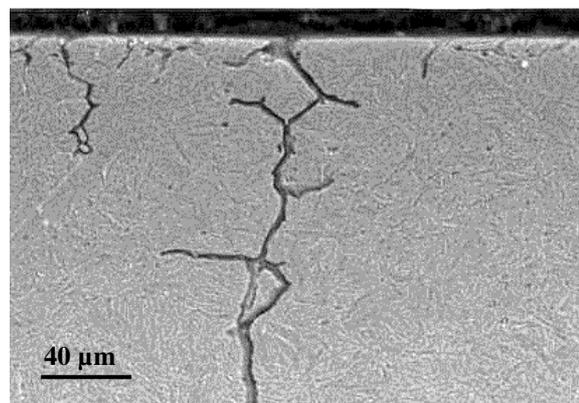
Fig. 14. The spreading cracks on grain boundaries, etched condition, REM

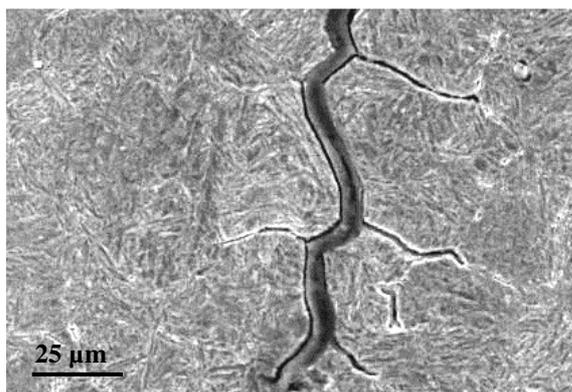
Fig. 15. More detailed view of Fig. 14, REM

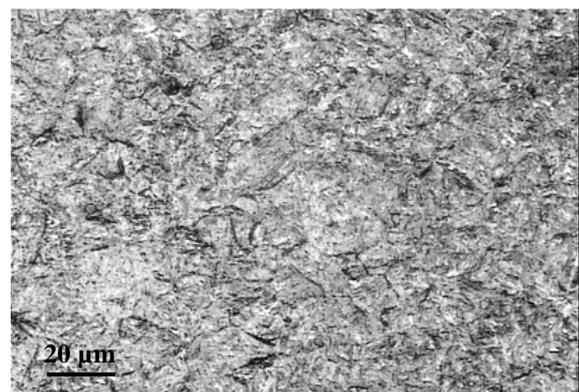
to the state after carburizing and hardening. The microstructure was consisted of martensite and retained austenite (Fig. 16). The microstructure in the transitional area of diffusional layer was mainly formed of bainite (Fig. 17) and bainite and ferrite was formed in core (Fig. 18). The share of ferrite in the microstructure in cross-section of the tooth was approx. 10 % [9-14].

Fig. 16. Microstructure of surface diffusional layer, martensite and retained austenite, etched Nital 3 %

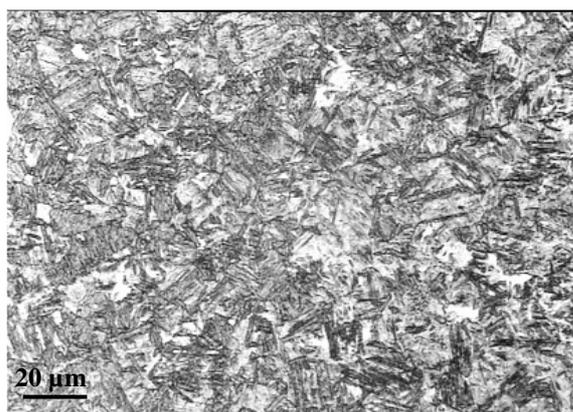
Fig. 17 The transitional area of diffusional layer formed by bainite, etched Nital 3 %

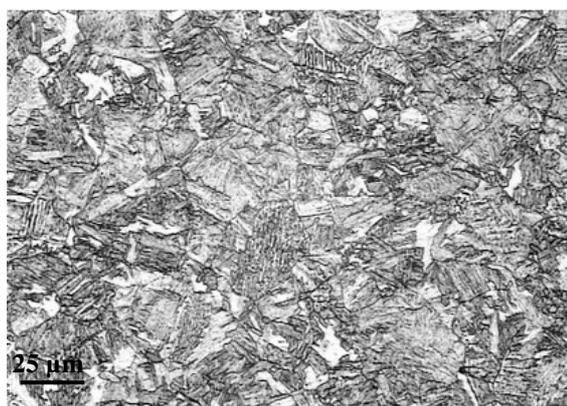
Fig. 18 The microstructure in the core of the cogwheel consisting of bainite and ferrite, etched Nital 3 %

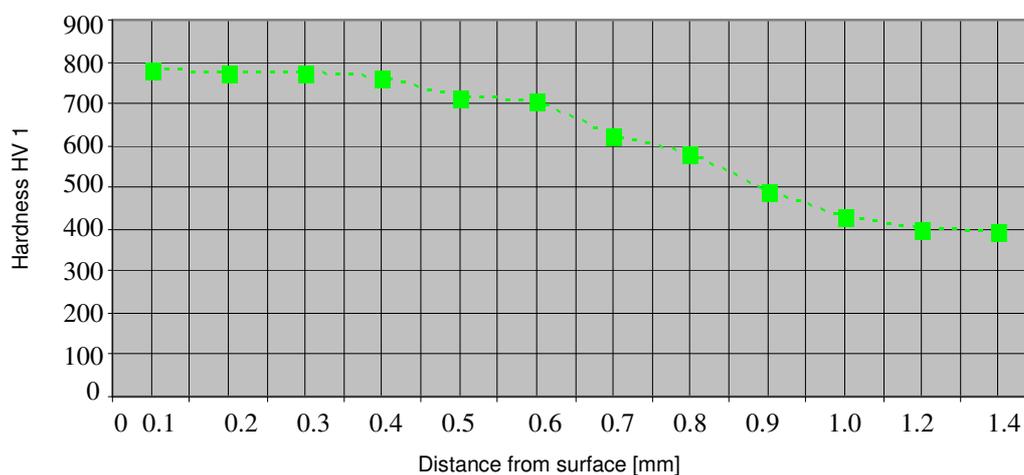
composition of material is suitable for 16MnCr5 DIN EN 10084, which is normally used for the production of gears [15, 16]. The evaluation of depth of surface diffusional layer was made in cross-section of middle diameter of cogwheel according to DIN 50 190. The hardness was measured by Vickers using Zwick 3212 with a micrometer shift table. The graph of hardness in the cross-section of the cogwheel's tooth is illustrated in Fig. 19. The depth of carburizing layer in accordance with DIN 50 190 corresponds to value 0.75 mm.

Fig. 19. The graph of hardness in the cross-section of the cogwheel's tooth

The thickness of surface diffusional layer measured on the tooth of cogwheel corresponds to the value 0.75 mm, i.e. the minimum value of thickness. The plastic deformation of the material can be prevented by reinforcing of components with sufficient thickness of the surface layer. This surface layer is formed by martensite. In practice, the highly stressed gears of gearboxes of larger machines have a thickness of layer with a value from 1.0 to 1.3 mm. After the grinding of the functional surfaces of gear's teeth, it is necessary to use non-destructive defectoscopic control of grinding cracks,
