# THE ANALYSIS OF CAUSES OF LORRY PISTON COMBUSTION ENGINE DAMAGE

*The article deals with analysis of causes of lorry piston combustion engine damage. For documentation and analysis of causes was used macroscopical, microscopical and scanning electron microscopy. The analysis showed that the reason of fatal damage resides in production process of lorry combustion pistons which proved in implication of fatigue damage and subsequent burnout in two piston place.*

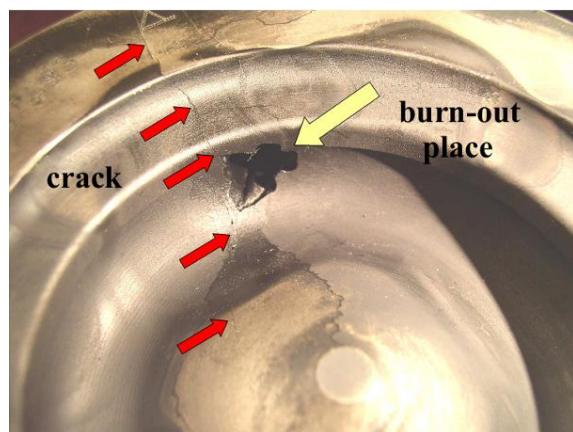
Two damaged pistons of lorry combustion engine were used for analysis. The damaged pistons in engine were changed before automobile had done 10000 km. Both damaged pistons were burnt out same in active and the most exposed parts of piston (Fig. 1) and in sideways of piston (Fig. 2). Crack occurred closely (red arrows) to burnout parts which

*Fig. 1 Burnout place and crack in active part of piston*  
(full colour version available online)

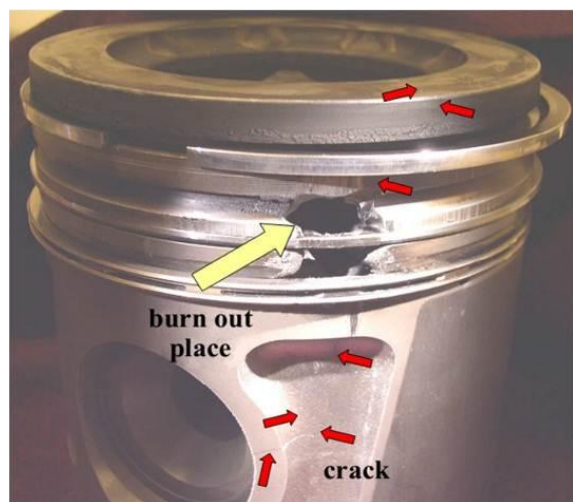
*Fig. 2 Place of burnout sideways of piston and crack propagation*  
(full colour version available online)

Two base features of piston degradation (except abrasion) were identified by visual investigation of damage piston combustion engine. At first the crack was created which rose up to the hole into piston pivot (Fig. 2) and stopped almost at the middle active piston part. The second feature was relatively big burnout holes in active and also sideways part of the gear piston. The seal ring was joined with piston in burnout place, distinctively abrasively worn and damaged. Due to the burnout localization close to the crack it can not be stated that burnout was initiator of piston damage but burnout was result of crack formation and its propagation in exhibition process of piston. In that case attention was focused on crack which had the same shape in both damaged combustion engine pistons.

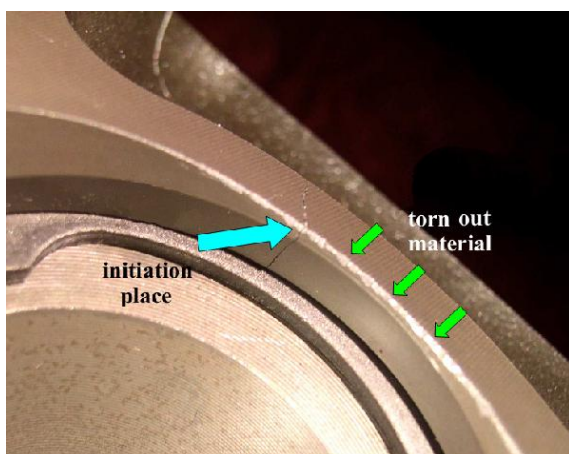
External cylindrical surface was worked on the base of morphology by roughly lathe-turning. Probably, cutting tool caused tearing out of material by wrong machining parameters in hole place for piston (Fig. 3) from hole edge for piston pivot (green arrows) in consequence relatively sharp and large notches were created at that place.

Fig. 3 Split off piston edge of pivot after machining  
(full colour version available online)

On the base of carried out analyses it can be stated that the most probable cause of piston damage during exhibition process is caused by wrong machining parameters of external cylindrical piston surface. Parts of material were torn out in hole place for piston pivot during machining. This place is cyclically also dynamically strained during the activity of

The conclusion states that during whole production process conditions of individual technological operations are needed to respect. Not respecting of define conditions can lead to damage of component and it means to distinctive decrease of lifetime and actually to complete destruction of constructional unit which part is component [11].

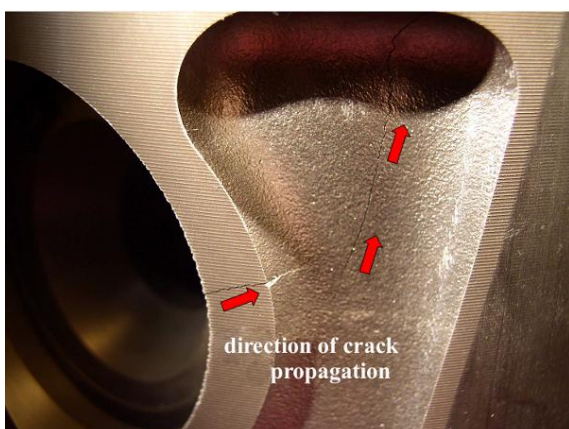
That way damaged hole edge had effect as the initiation place for formation of fatigue crack which after achieving hole for leading away excess oil from wipeable ring and subsequently propagated in its direction. That documents Fig. 4 where sudden change is seen in the orientation during crack propagation. Material is in the closeness of that hole weakened what enables its next propagation up to the active piston part. In this place high temperatures and pressure effect for material of piston. Fuel mixture was getting into material volume by the crack what caused also local melting down of fracture surface and by medium pressure caused its removal through crack and the weakest section out of piston material.

Fig. 4 Direction of fatigue crack propagation  
(full colour version available online)

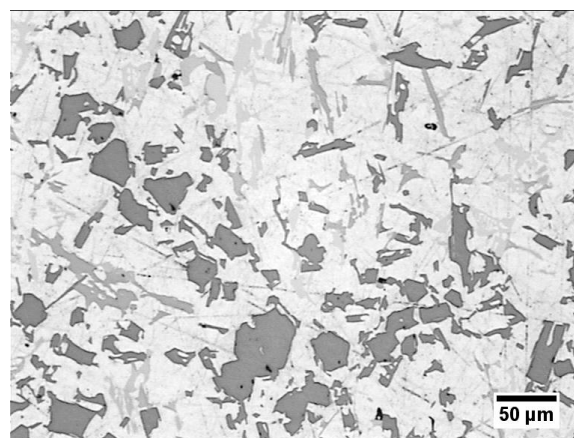
Microstructure of piston cast was analysed in bottom, middle and active part of piston. In all three areas microstructure was formed by base matrix on the basis of aluminium solid solution, sharp-edge Si particles and interdendritic spaces were filled by eutectics. On the base of microstructure it can be stated that it is alloyed hypereutectic Al-Si alloy [10]. Microstructure of active piston part is documented in Fig. 5, its middle part is given in Fig. 6 and bottom part of piston is shown in Fig. 7. Microstructural heterogeneity in individual piston parts is observed in photographs.

Fig. 5 Microstructure from active part of piston

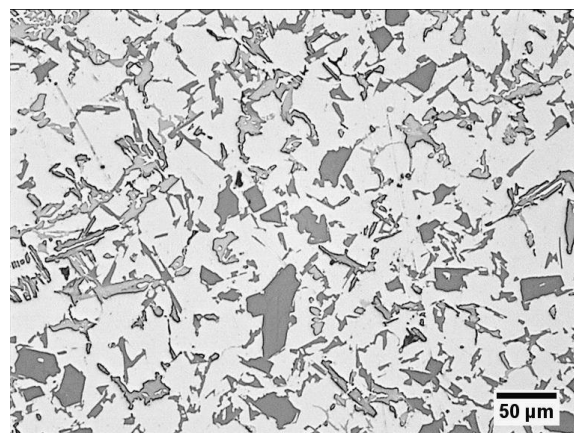
Fig. 6 Microstructure from middle part of piston

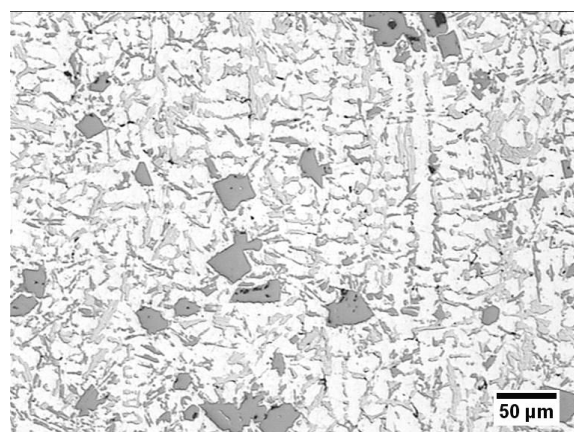
Fig. 7 Microstructure from bottom part of piston

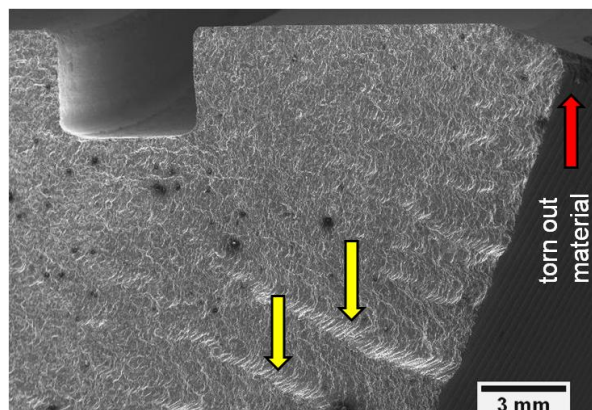
In Fig. 8 fracture surface in place of the fatigue crack initiation can be seen. Typical fatigue (relaxation) lines were observed in

fracture surface which proceeded from place of initiation fracture in this case from place where parts of material were torn out from surface during machining. Groove for safety ring of piston pivot was situated in left upper part of image.

Fig. 8 Surface fracture in place of crack origin, fatigue lines, split off material

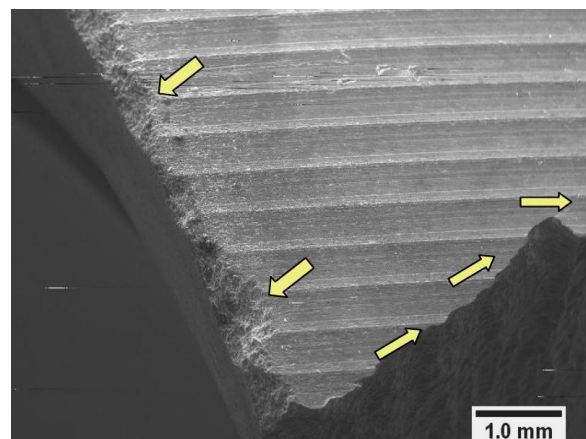
Fig 9 documents micrograph of external machined surface which contains tracks caused by cutting tool. Places were observed in edge (left) where material was torn out during machining of surface. Same damage (tearing out) was observed in opposite side of hole for piston pivot.

Fig. 9 Machined piston surface, split off material and fracture surface
