# IDENTIFICATION OF THE BREAKDOWN AND ANALYSIS OF TRANSFORMER 22/0.4 KV

The paper deals with the identification of the breakdown of the transformer withdrawn from operation because of repeated reaction of transformer protections. Successively the transformer was put of operation, removed from the distribution and put to diagnostic measurements. For identification of the failure were used diagnostic methods, e.g. Sweep Frequency Response Analysis (according to IEC 60076-18), measurement of winding resistances, measurement of isolation resistances and capacitances. The results were compared with reference measurements.

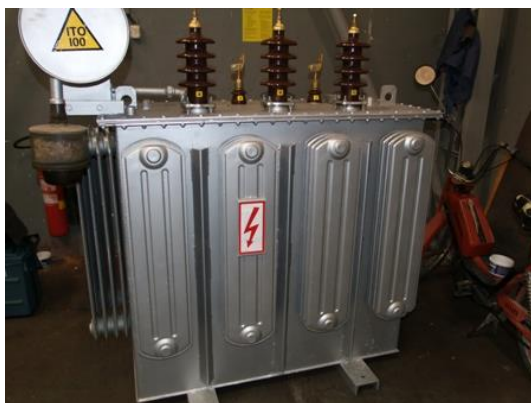
Fig. 1. Tested Transformer.  
(full colour version available online)

As it was mentioned in the introduction, the transformer (Nameplate Data in Tab. 1, Fig. 1) was withdrawn from operation for the reason of repeated transformer switch - off by over - current and differential protection.

The transformer was in 2011 subject to the planned repair work, when the bushings, conductor leads to bushings on it were

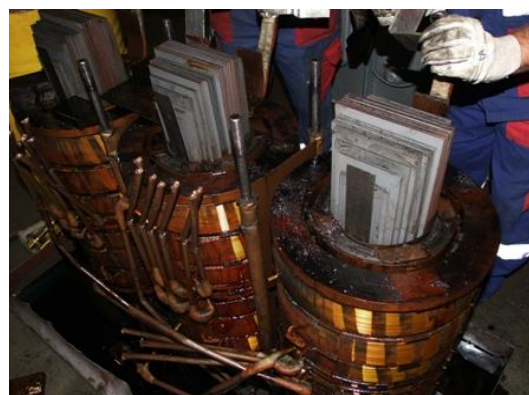
Fig. 8. Dismounting the transformer core and coils.  
(full colour version available online)

The coils in these transformers types are made from aluminium on which a layer of isolating varnish is coated (Fig. 7 and Fig. 8). Isolating varnish is being old through natural way and frequent mechanical stress at short circuits, at atmospheric discharges and overload of the transformer cause its speed – up degradation. This causes micro cracks on the isolating varnish what causes an emergence of an interturn short circuit, because the windings are wended stock - a block. When under the influence of mechanical stress and temperature ageing there occurs a damage of the insulating varnish on the coil windings an interturn short circuit occurs in the contiguity. In that place an arc begin to burn and so chemical reactions begin in the transformer oil. Their results are a formation of methane, acetylene, ethane, furane and other gases. At the burning of arc in the place of interturn short circuit (Fig. 9) the temperature increases, melts the adjacent windings and thus form bigger amounts of gases dissolved in oil, and in the case if the transformer does not have Buchholzs' relay, eventually the transformer protections are adjusted incorrectly its destruction occurs and subsequently ecological and economics losses. The following pictures illustrate dismantling works of the transformer resulting in revelation the hidden interturn short circuit of the phase C of the primary winding. The analysis and study of the sample from the burnt part of the winding by means of the microwave resonator technique determined the value of loss factor belonging to the mixture of the sintered aluminium, bitumen and transformer oil.

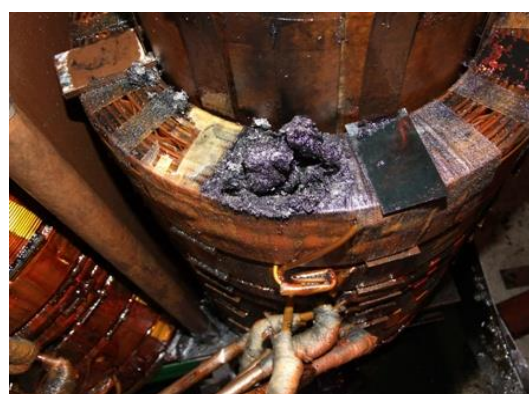
Fig. 9. Photo of interturn short circuit.  
(full colour version available online)

By means of the analysis of the measured frequency responses the interturn short circuit was found on the primary winding of the third phase C. The frequency responses represented on Fig. 2 and 3 show the difference in their forms. They are caused by impedance change, capacitances, and scattering inductances of the transformer winding. In the Fig. 4 there are for comparison represented reference courses of windings connected in delta connection of the new transformer.
