NODULAR CAST IRON FATIGUE LIFETIME IN CYCLIC PLANE BENDING

Marián Kokavec^{1,*}, Radomila Konečná¹, Gianni Nicoletto²

Nodular cast iron;
Fatigue;
Surface condition;
Cyclic plane bending;
Microstructure

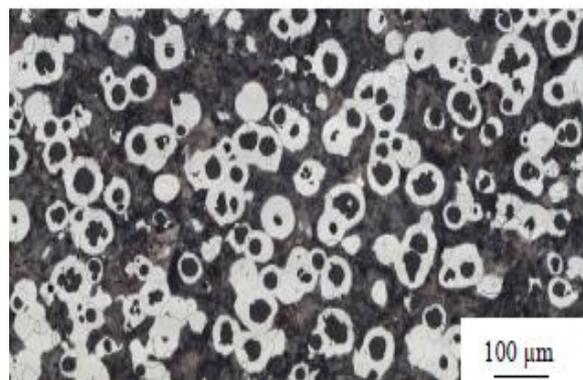
The structure of NCI was characterized by pearlite/ferrite matrix with slightly different content of ferrite (in the range from 20 to 40 % or Fe 30 according to the standard) in different specimens. The graphite nodules were observed in fully globular shape (VI) and no perfectly globular shape (V) and they were located in ferrite, Fig. 2. Size of graphite nodules was predominately ranging from 30 to 60 μm (6 according to the standard) and with a small number of nodules ranging in the size from 15 to 30 μm (7 according to the standard). Graphite nodules count N was 260 mm^{-2} in average. Three sets of fatigue

Fig. 2. Characteristic microstructure of the studied NCI, etched with 3 % Nital

and finally nodular shape going from the surface to the core of material. The combination of lower strength of pearlite matrix with lamellar graphite is expected to negatively affect the surface layer strength in case of fatigue loading because it results in early crack initiation compared to the typical nodular cast iron structure, see Fig. 2.

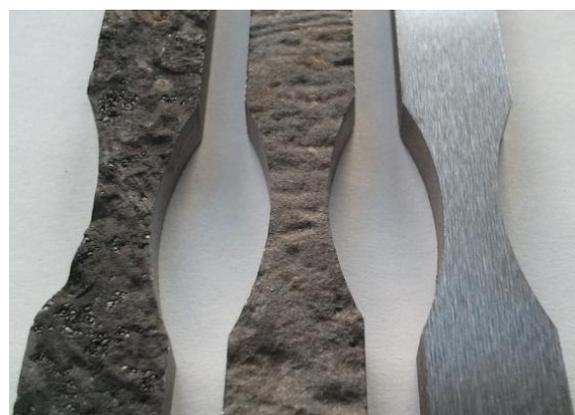
Fig. 3. Surface condition of specimens (from left as-cast, sand blasted, fine ground)

specimens (for geometry see Fig. 1) were prepared. The first set had the evaluated surface in the as-cast condition (Fig. 3) and the opposite ones were grounded in all cases. Second set of specimens had evaluated surface after sand blasting of the as-cast surface, Fig. 3, by using compressed air pressure (i.e. 1 MPa); the erodent abrasive was of SiC sand (i.e. grain size 250-300 μm). The tested surface of the fine ground specimens, Fig. 3, had a smooth finish achieved by removing the casting surfaces by machining of plates on a vertical milling machine and finished by soft grinding on a disk sander. The soft grinding was conducted by ceramic aluminum oxide wheel under the conditions of the grinding speed of 30 m/s, down feed 0.020 mm/pass.

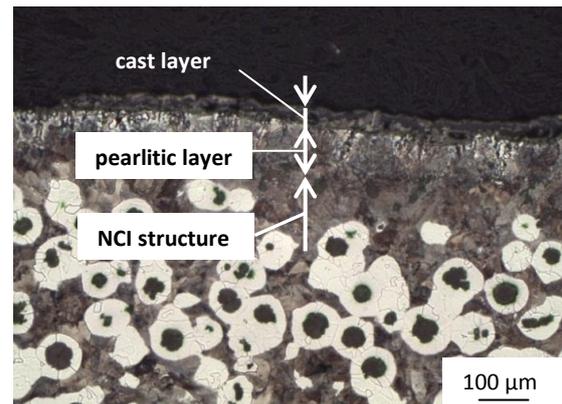
The surface and subsurface characteristics were metallographically investigated on cross sections perpendicular to the fracture surface and are discussed with reference to Fig. 4. Typically, the as-cast surface is covered by a thin cast layer made of oxides and pores. Just below this surface layer, a pearlitic layer with variable thickness, formed due to rapid solidification and cooling was found. Below these two layers and for the rest of the cross-section, the base NCI structure was found, see Fig. 2. Thickness of these layers and the surface roughness coefficient R_v were measured and are summarized in Table 2.

Fig. 4. Typical as-cast surface structure, etched 3 % Nital

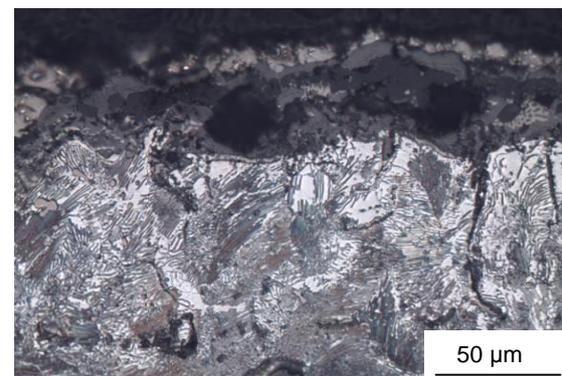
The thin cast layer (Fig. 5) contained pores and cavities, which affect fatigue crack initiation. Fig. 6 shows that in the sand blasted specimens the pearlitic layer contains lamellar graphite, which gradually turns into vermicular

Fig. 5. Detail of surface layers of specimens with as-cast surface

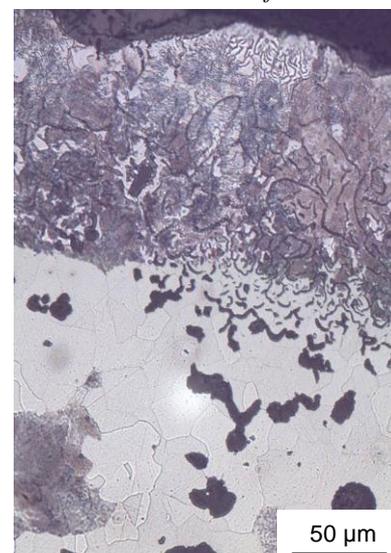
Fig. 6. Magnified view of surface layer after sand blasting

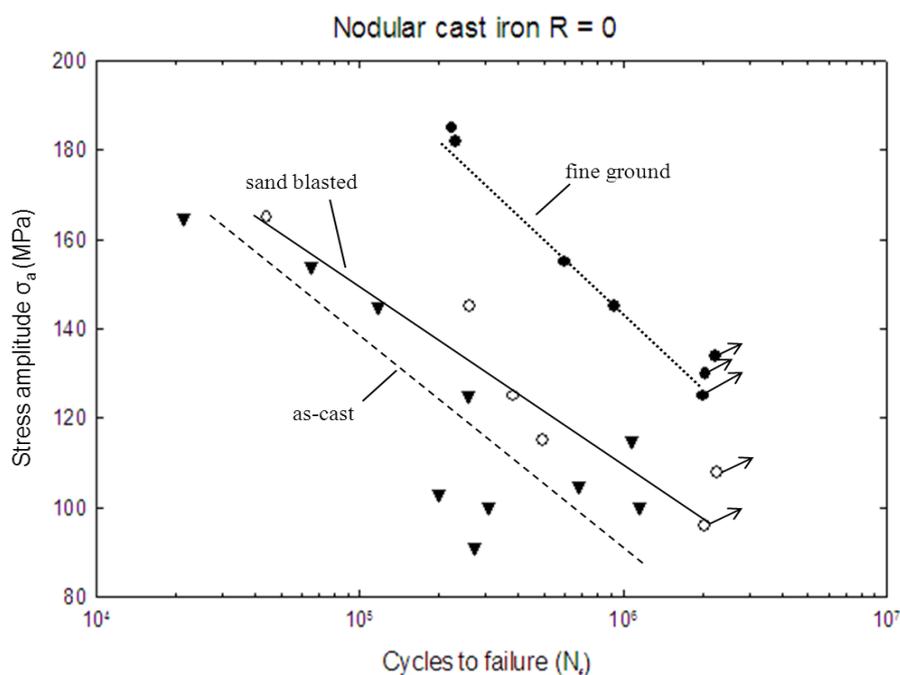
Fig. 7 shows the results of fatigue tests for all specimens. Trends of the S/N dependence for different surface conditions were identified.

A ranking of the three surface conditions in fatigue is experimentally obtained with the best performance associated to the fine ground surface. At 10^6 cycles, the fatigue strength shows a decrease of approx. 20 % going from a fine ground to a sand blasted surface.

The scatter of results for specimens with as-cast surface was very large and estimation of the fatigue limit of these specimens from the S/N dependence was difficult. The large scatter of results can be explained by the presence of many defects in the cast surface layer, from which the fatigue cracks are initiated very quickly [7]. With regard to the effect of vertical roughness coefficient (Tab. 2) on fatigue strength, as expected, the fatigue strength increases as the surface becomes smoother. As-cast and sand blasted surfaces give a similar response in fatigue behavior.

Fig. 7. S/N fatigue data after cyclic plane bending of the NCI specimens

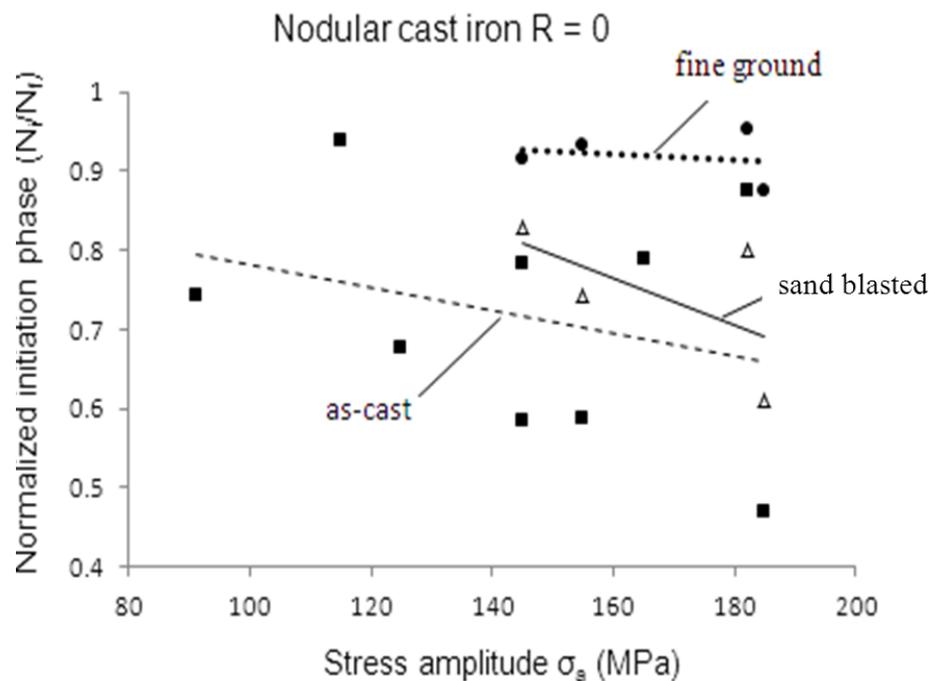
Fig. 8. Duration of initiation phase as a function of stress amplitude and surface condition

However, the surface condition is expected to influence the fatigue crack initiation considerably with a strong effect associated to high surface roughness or by surface defects. The dependence of the crack initiation phase duration on the applied stress amplitude is shown in Fig. 8, and it is defined as the number of cycles to a predefined drop in maximum stress (i.e. 5 %) normalized by the total fatigue life. Most of the fatigue life (i.e. > 0.9) of the fine ground specimens is spent for crack initiation. On the other hand, as-cast and sand blasted surfaces favor early fatigue crack initiation and a considerable fraction of the fatigue life is spent for crack propagation to failure (i.e. < 0.6).
